Analysis of Defects In Solid Rocket Motors Using X-Ray Radiography

S Remakanthan, Moideenkutty KK, R Gunasekaran, Cherian Thomas & C R Thomas

Rocket Propellant Plant, Vikram Sarabhai Space Centre, Trivandrum

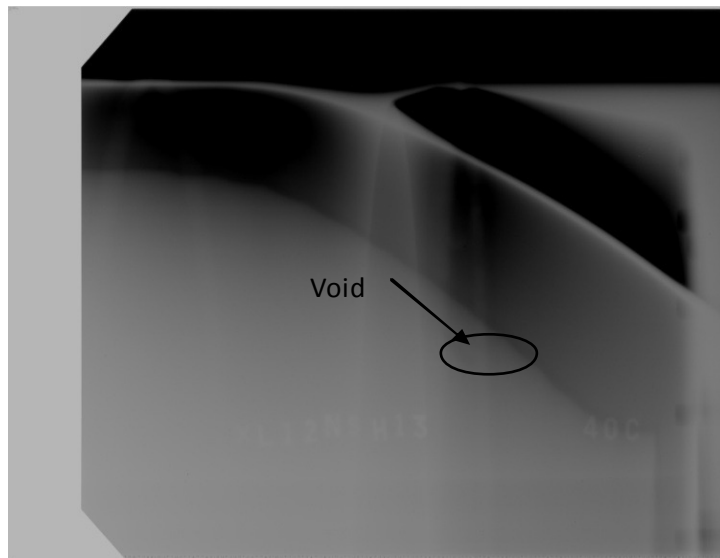
Fig.3 Void in propellant - Initial x-ray image

Voids appear as denser spots in the radiograph. From the basic density of the radiographic film if dark spots are seen, it indicates that the effective web of the grain at that radial location corresponding to each dark spot is less than from the normal web. This can be due to presence of a single void or number of voids in a line. With naked eye it will not be possible to assess the intensity of darker spots. Density of the darker spots should be compared with the density of normal region. Film densitometer is used to compare the density of different regions [2]. Basic film density varies based on the type of film, exposure time, developing condition, etc. A typical radiograph of void in a large rocket motor is shown in fig.3.

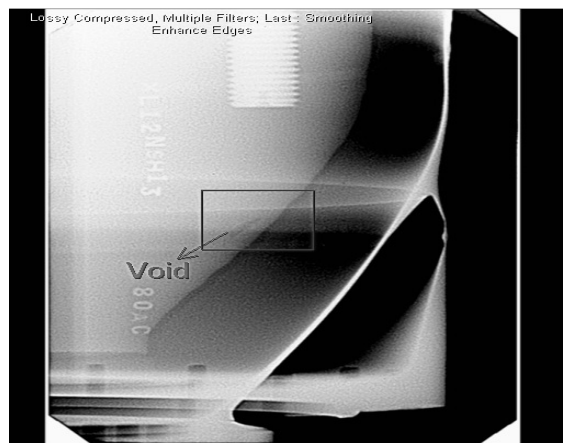
Fig.5 X-ray image after enhancement

With digitization and image processing techniques using a film digitizer, the sharpness and the contrast of the image can be enhanced. Fig 5 shows the propellant void after enhancement.

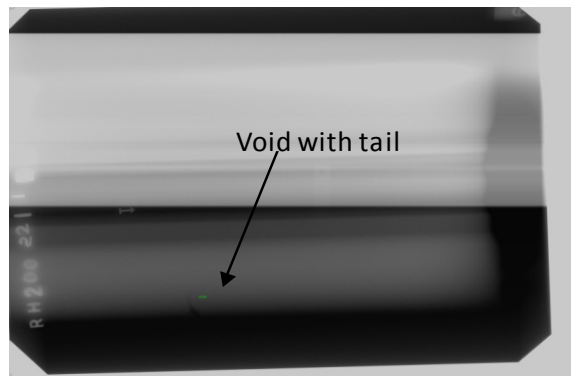
Fig.6 X-ray image of a void with tail

In some cases the voids are noticed with tail on the lobe in the axial direction. These defects were observed in free-standing propellant grains processed with pvc-plastisol based composite propellant. Fig.6 shows a propellant void with tail. The reason for the characteristic shape of such defects could be traced to the high temperature physical curing process. Voids in the propellant are released and moved towards the head region while heating. Due to the initiation of curing process the propellant viscosity increased and the voids were entrapped in the propellant with tail. If the tail has a sharp corner, there would be a chance for crack initiation. In such cases, voids having sharp corner or elongated shape in the radial direction shall not be accepted.

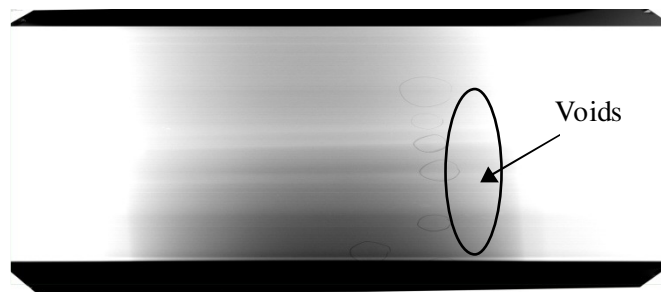
Fig.7 Radiograph of cluster of voids

Closely spaced voids are normally considered as single void of overall size equal to the linear dimension covering the outer periphery of these voids [4]. 'Cluster of voids' or porosity observed in some of the rocket motors could be correlated to presence of moisture in the propellant slurry or entrapment of air in the insulation free flap. Small single void shall be acceptable irrespective of their location and shape. Cluster of voids can cause early exposure of the insulation and makes the case thermally critical. Structural failure is expected when the voids are very close to each other. Since the size of the voids which are noticed as cluster in nature shows very low density compared to the large single void. Detailed investigation in density variations is essential for the estimation of these defects. Rotate the voids region towards the tangent and took tangential shots in higher density so that RT can ensure the region of cluster of voids whether it is in propellant or inhibition. Fig.7 shows the radiograph of cluster of voids in solid propellant.

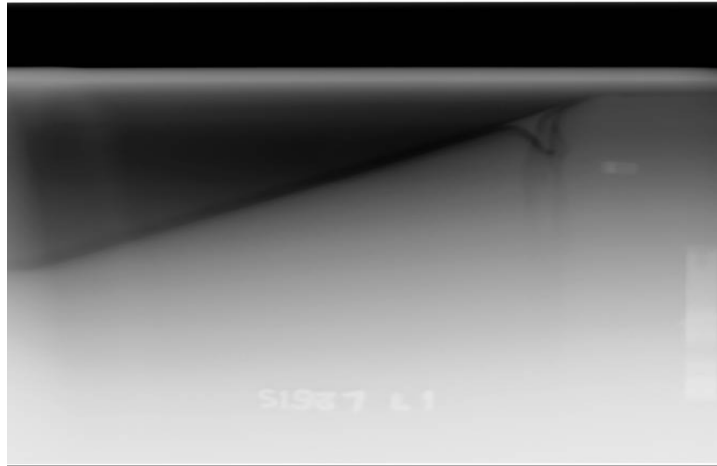
Fig.8 Propellant entrapment in loose flap

Propellant entrapment in the loose flap is another major defect occurred in the rocket motors. Rocket motor cases are insulated with rubber to prevent the transferring of high temperature during burning of solid propellants. Loose flaps are provided in the motor cases to accommodate the shrinkage of propellant during curing. In finishing operation these space are filled with resin. Due to improper filling of loose flap gaps voids may appear between loose flap and fixed insulation. If the voids are noticed at less than 25mm from igniter port opening, that region has to be refilled with resin [4]. A typical radiograph of propellant entrapment in the loose flap region is shown in fig.8

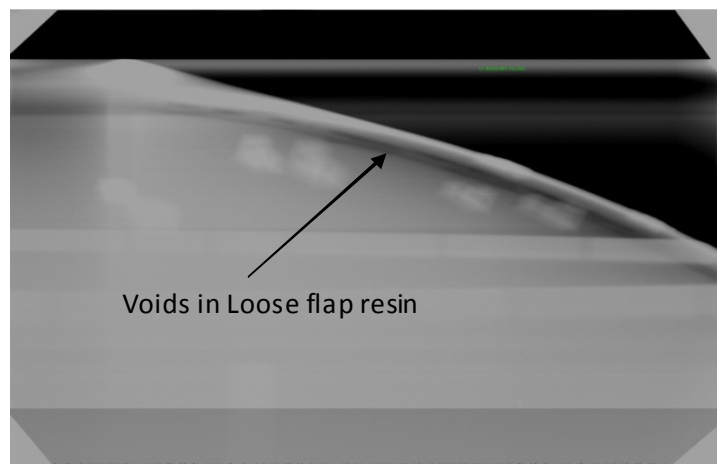
Fig.9 Digitized images of voids in the loose flap filled resin

At the time of casting suitable vents are punched in the loose flap region for the removal of air. In some occasions the propellant traces may be entrapped in the loose flap and detected through radiography. Figure 9 shows a radiograph having few voids in the loose flap filled resin.

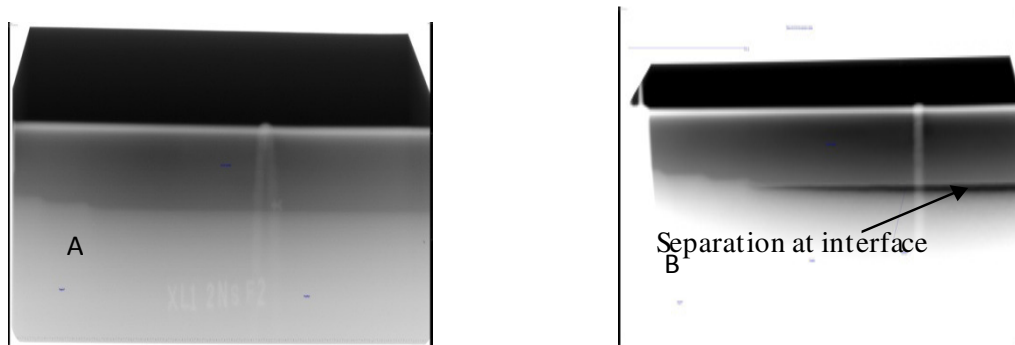
Fig.10 Radiograph of propellant/insulation interface

Separation between propellant and insulation is not acceptable in any solid rocket motors. The separation between propellant and insulation are considered critical and separation in the dome portion are viewed more serious than that occur in the cylindrical region. The delectability of separation depends upon the number of tangential exposures taken around the motor. Normally, separation is occurred due to the poor storage condition of the motor for a

The X-ray beam is focused at the interface and the film is positioned close to the motor. Fig 10-A shows the radiograph of propellant insulation interface. Due to the poor storage the interface got separated in a motor which is shown in figure 10-B.

long period. Normal practice observed during storage is the rotation of the case in a fixed interval. This rotation prevents the sagging of the propellant in one direction and prevents the tendency for separation.

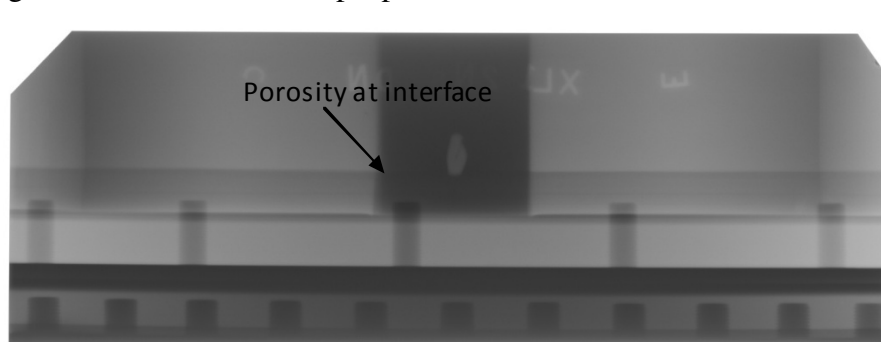
Fig.11 Radiograph of porosity noticed at the interface of propellant/inhibition

Both ends of the rocket motor are inhibited by curing of resin. End inhibition prevents the unwanted radial burning of propellant. Porosities are normally noticed in inhibition layers due to the entrapment of gases during the mixing of resin. Porosities on the top surface of end inhibition and between layers are acceptable. Fig.11 shows the radiograph of porosity noticed at the interface of propellant and inhibition. If severe porosity is present at the propellant interface, re-inhibition should be carried out. Film densitometer is used to compare the density of porosity region for the classification purpose.
